ADDITION, RENOVATIONS AND RECONSTRUCTIONS FOR
SPELLMAN MUSEUM
OF FORNEY HISTORY
200 S. BOIS D'ARC STREET - FORNEY, TEXAS 75126

FRAMING DETAILS

S3.1

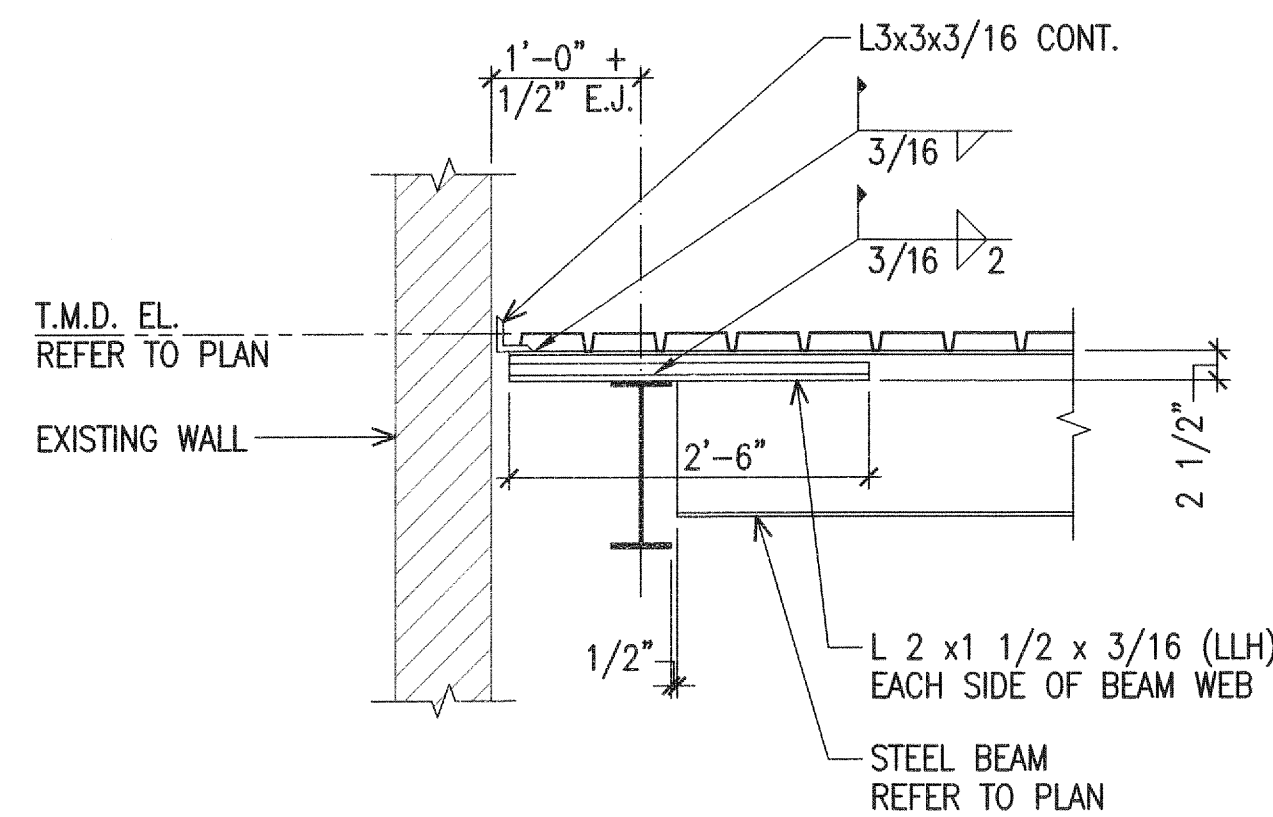
1 BEAM TO BEAM CONNECTION
DETAIL
SCALE: 3/4" = 1'-0"

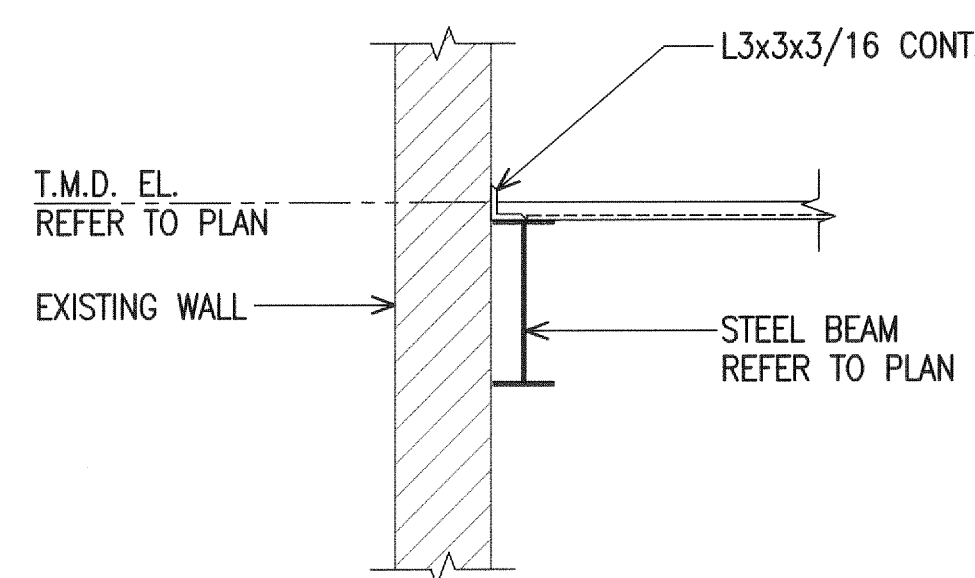
2 DECK TO BEAM CONNECTION
DETAIL
SCALE: 3/4" = 1'-0"

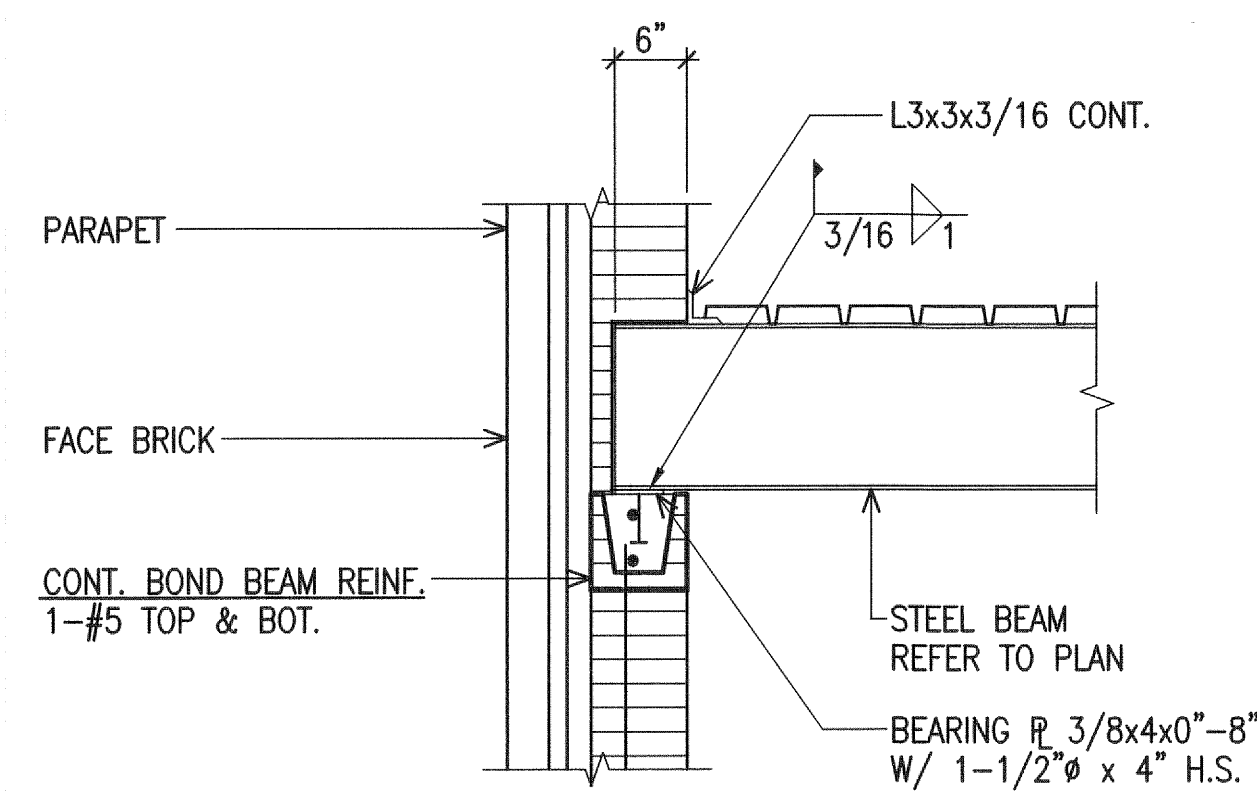
3 BEAM BEARING ON CMU WALL
DETAIL
SCALE: 3/4" = 1'-0"

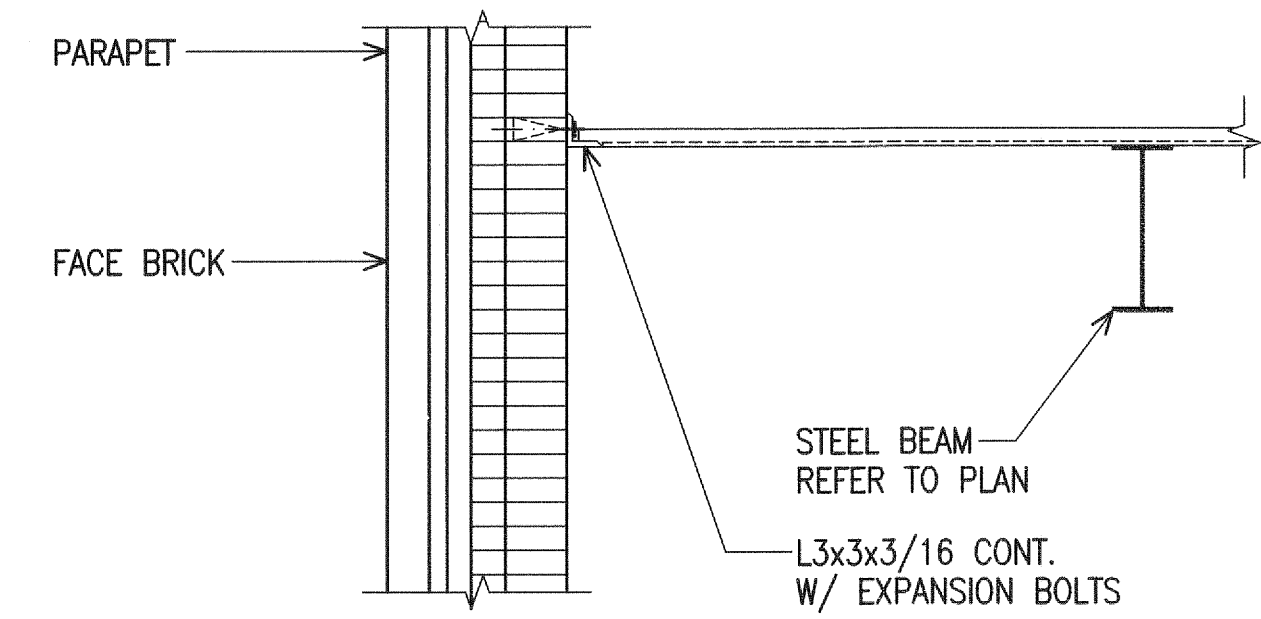
4 DECK TO CMU WALL CONNECTION
DETAIL
SCALE: 3/4" = 1'-0"

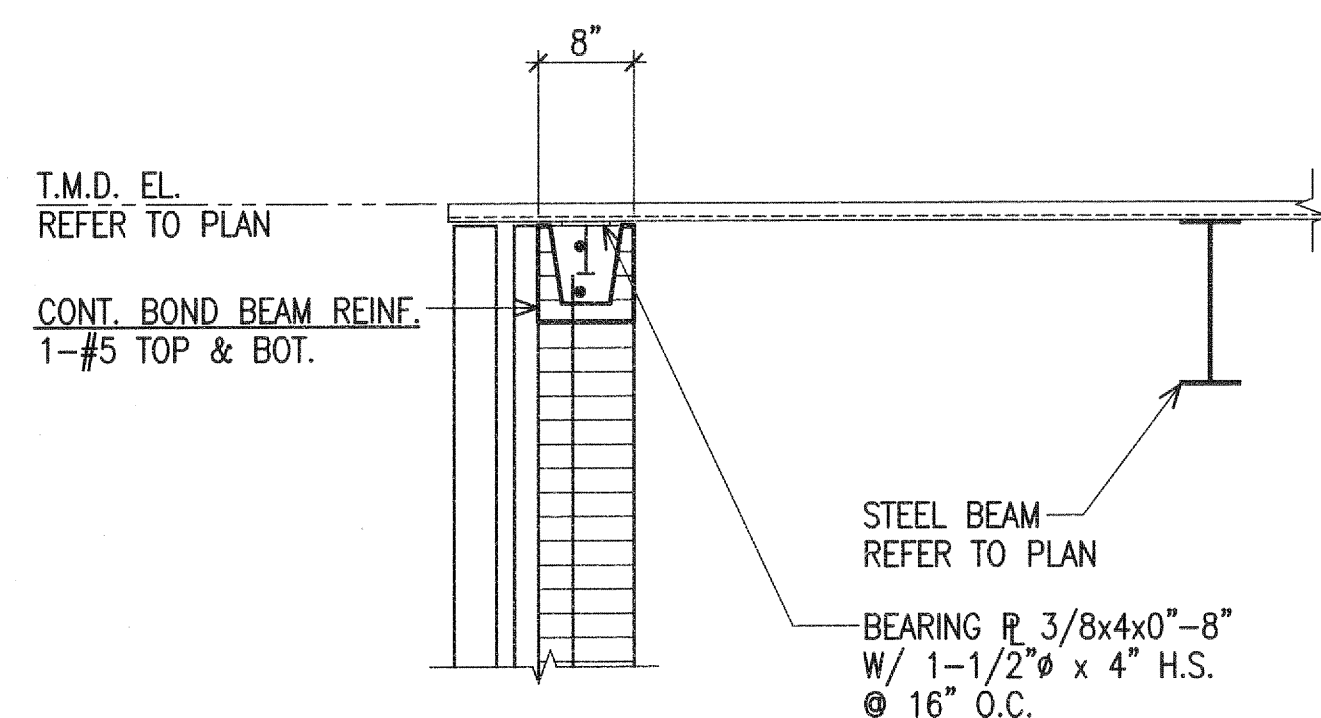
5 DECK TO CMU WALL CONNECTION
DETAIL
SCALE: 3/4" = 1'-0"

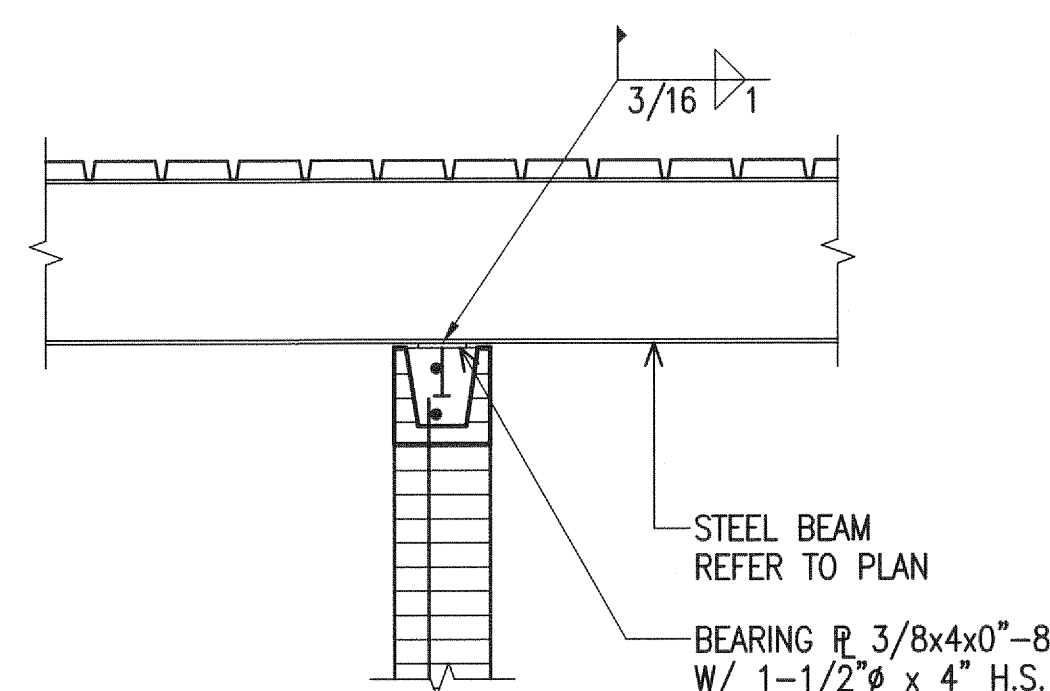
6 BEAM BEARING ON CMU WALL
DETAIL
SCALE: 3/4" = 1'-0"

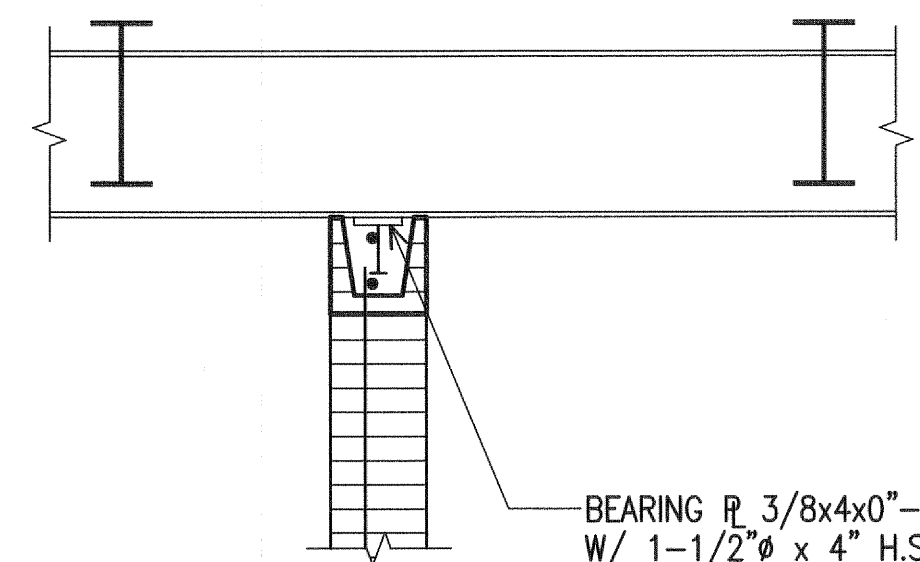
7 BEAM BEARING ON CMU WALL
DETAIL
SCALE: 3/4" = 1'-0"

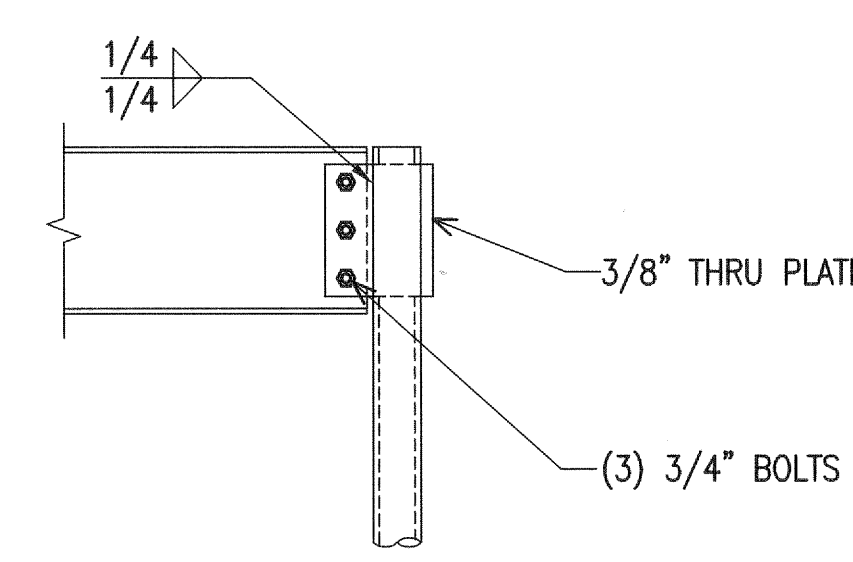
8 BEAM TO COLUMN CONNECTION
DETAIL
SCALE: 3/4" = 1'-0"

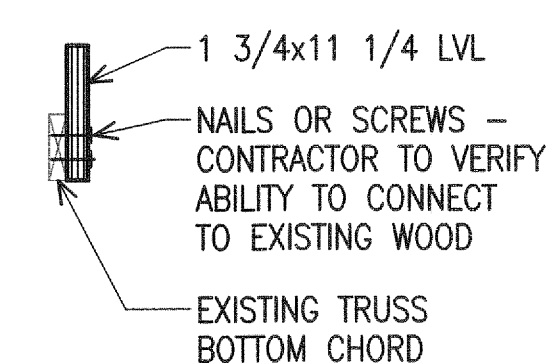
9 NEW BEAM TO EXISTING TRUSS
DETAIL
SCALE: 3/4" = 1'-0"

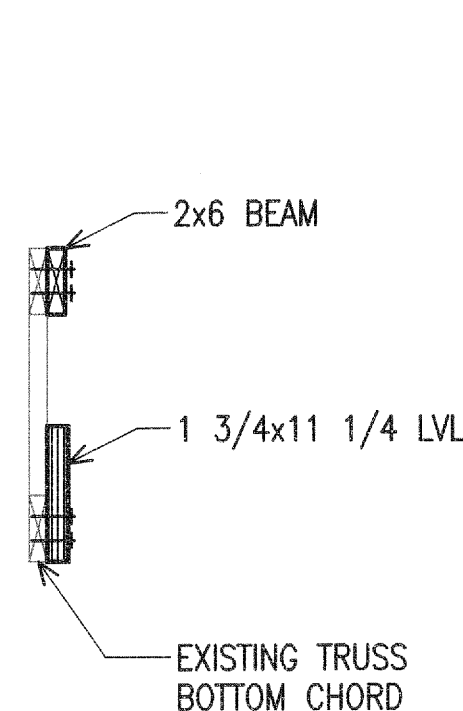
10 NEW BEAM TO EXISTING TRUSS
DETAIL
SCALE: 3/4" = 1'-0"

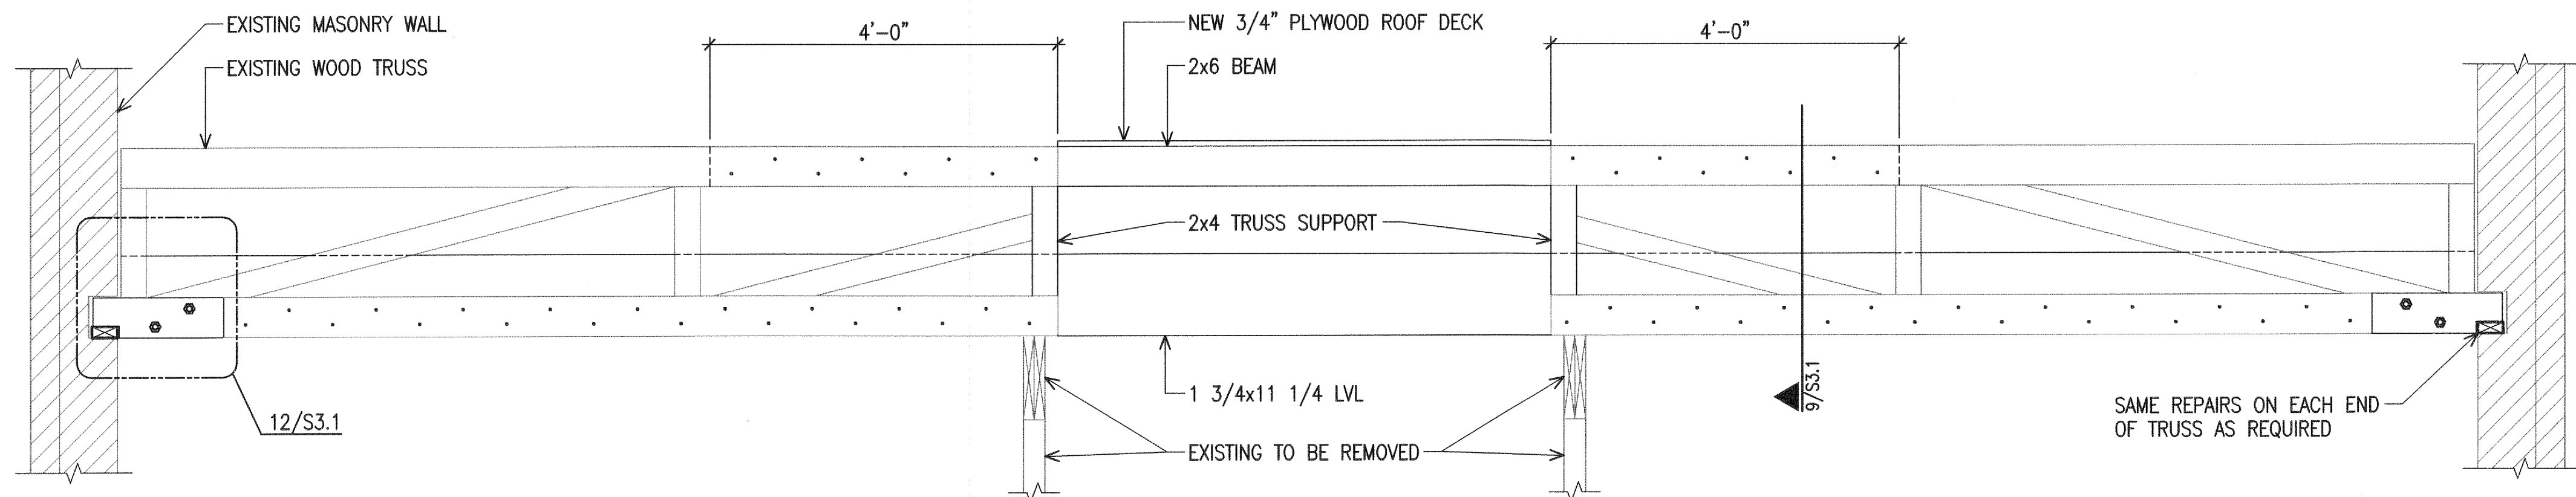
11 EXISTING STRUCTURE REINFORCEMENT (TYPICAL AT 5 TRUSSES)
DETAIL
SCALE: 3/4" = 1'-0"

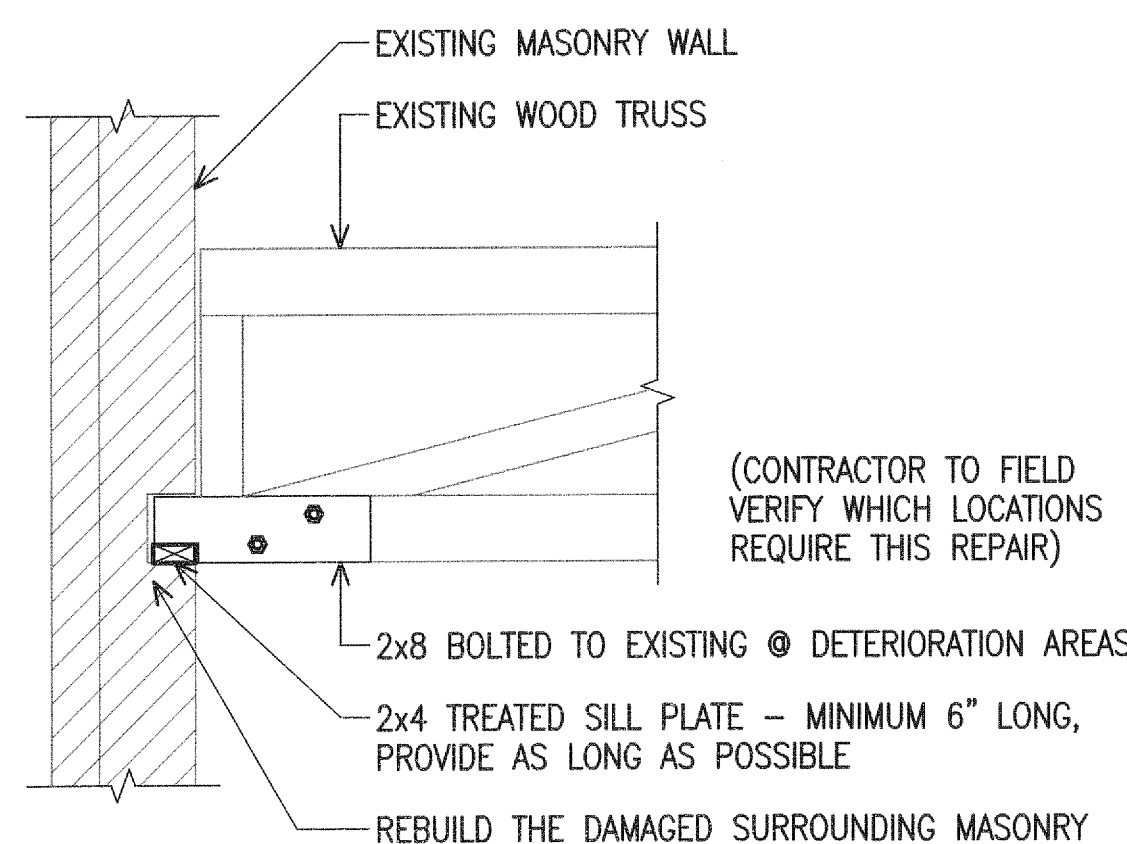
12 EXISTING STRUCTURE REINFORCEMENT
DETAIL
SCALE: 3/4" = 1'-0"

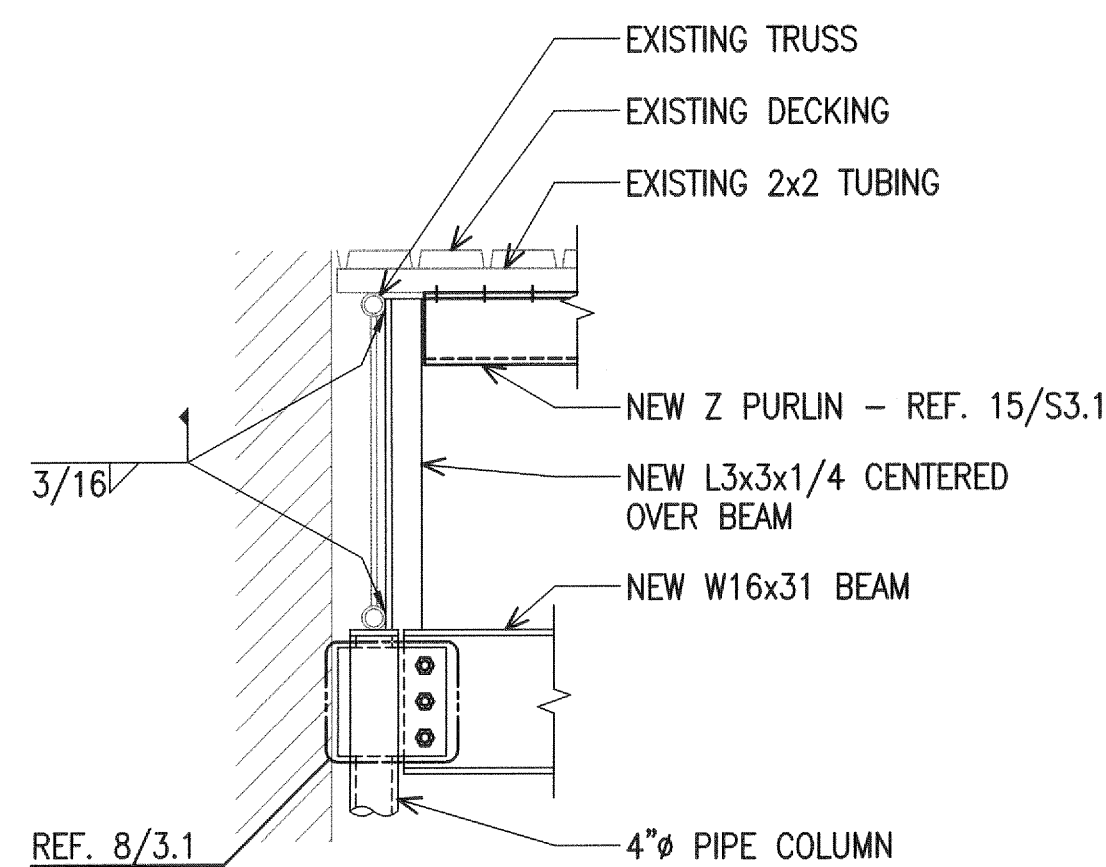
13 EXISTING STRUCTURE REINFORCEMENT
DETAIL
SCALE: 3/4" = 1'-0"

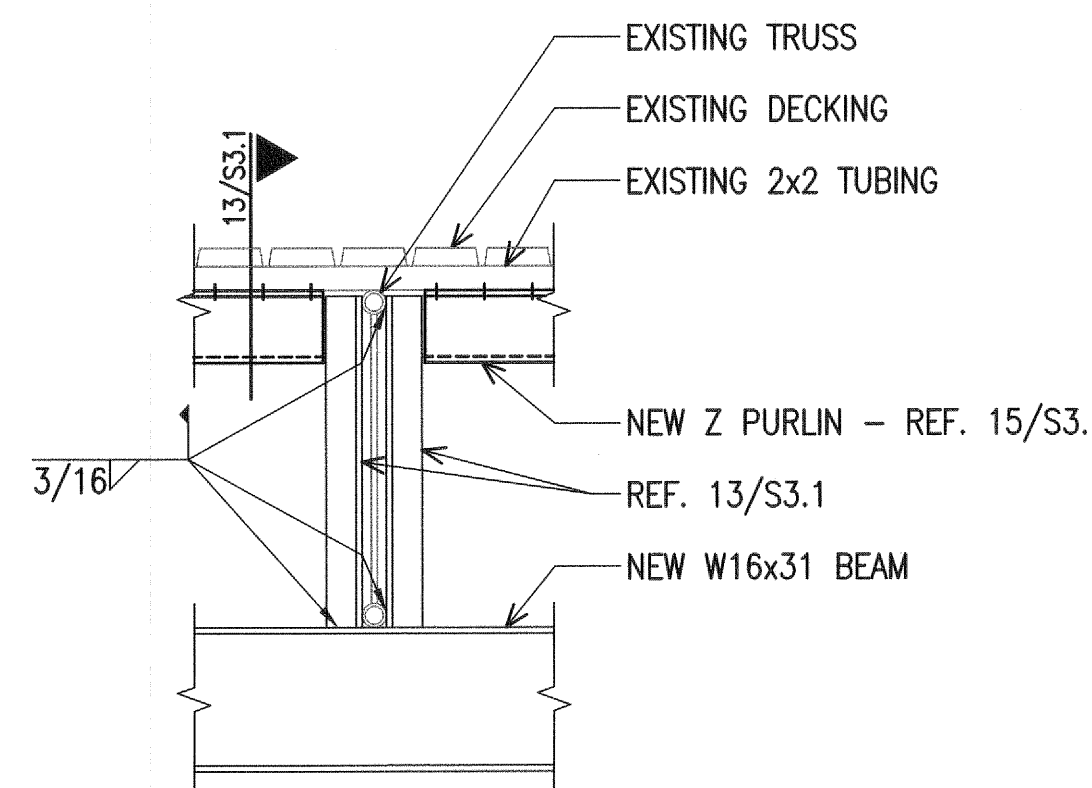
14 EXISTING STRUCTURE REINFORCEMENT
DETAIL
SCALE: 3/4" = 1'-0"

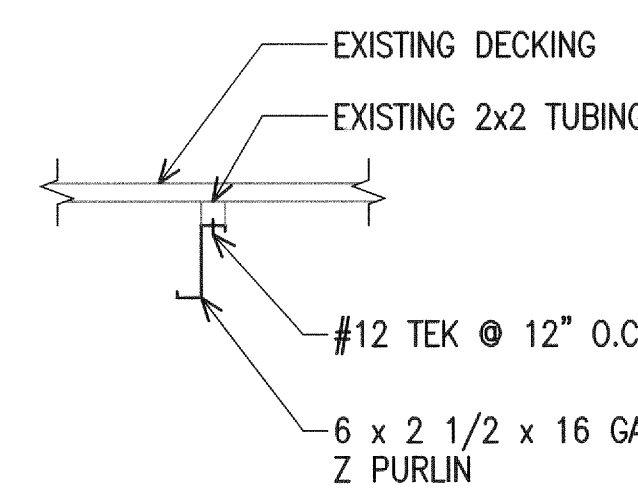
15 EXISTING STRUCTURE REINFORCEMENT
DETAIL
SCALE: 3/4" = 1'-0"

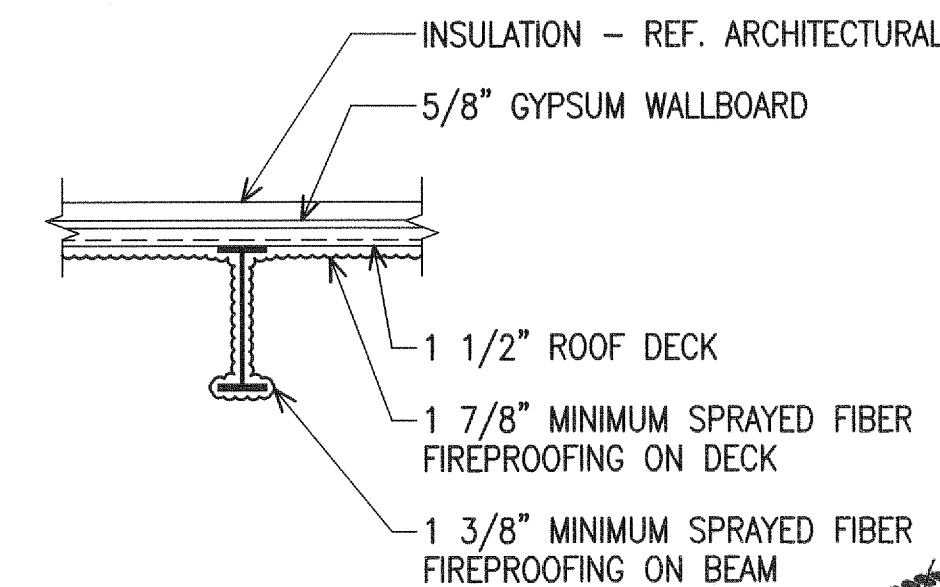
16 ROOF FIRE RATED STRUCTURE
DETAIL
SCALE: 3/4" = 1'-0"
